# **DIRECT IMAGE PROCESSING OF CORRODING SURFACES APPLIED TO FRICTION STIR WELDING**

## **ABSTRACT**

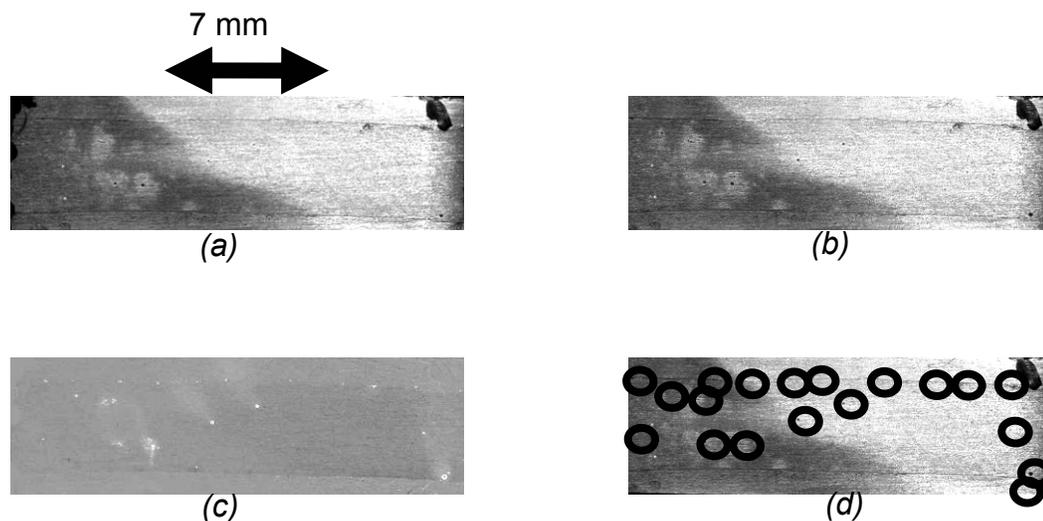
**Figure 1.** Digitized images and a processed image of Alloy 7075 taken at the start of potential scanning. Image (a) and (b) were taken 55s apart. The locations of events are clearly seen in the processed differences of the images in (c). Image (a) is again shown in (d) with the location of the corrosion events marked by black circles.

Figure 1 shows an application of the imaging technique. The transparent tape used to mask the exposed area is most easily seen along the tops and bottom of the images in Figure 1. Figure 1a shows a dark area to the left. This area was produced by the NaOH etching. Within this area there are lighter roughly circular areas, which surround sites where localized corrosion occurred during the initial open circuit exposure.

Prior to polarization, the open circuit potential was around -770 mV<sub>Ag</sub>. Images shown in Figure 1a and b were recorded at -864, and -819 mV<sub>Ag</sub>, close to the start of the potential ramping. On visual observation there are no discernable differences. However, digital subtraction of image b from a resulted in the difference image shown in Figure 1c, where corrosion sites are clearly located. They appear as white spots with some showing comet-like tails due to pH indicator changes. All the tails were in the same direction and resulted from solution convection, which is generally seen even in the confined volume of the 25 mm container. In contrast to the gray scale in Figure 1c, the original color of the difference image showed the comet tails were green close to the spots and changed to red with distance from the corrosion site. The amount and hue of the color change is a function of the subtraction parameters and the times the real images were taken. The red color was due to a decrease in pH to  $<4$ , the lower limit of the pH indicator. The green was produced by the first image having higher red intensities than the same areas in the second image, so the result of subtraction is a lower red intensity in the difference image, which is perceived by the human eye as a green color. It should be noted that the color of the difference image represents relative changes in pH as a function of time, rather than absolute values of pH. The green color of the tails became the white color shown in the figure when the image was converted to a greyscale representation for publication.

The above analysis demonstrates a number of different inductions of sites of corrosion. Circles in Figure 1*b* have marked the indicated sites of corrosion taken from Figure 1*c*. One site is clearly above a taped area. The cause of this indication is not known for certain. It could have been due to crevice corrosion penetrating under the coating, but post exposure examination of the sample showed no evidence of crevice corrosion under the tape. Another possibility was the presence of a particle floating in the solution. The movement of these particles is often seen in the solutions and care must be taken to eliminate all particulates within the solution, on the sample, or on other components in contact with the solution.

The corrosion scenario that accounts for the observation in Figure 1 is associated with open circuit corrosion from adding the chloride solution followed by the application of a more negative potential. The corrosion was terminated by the applied potential, but the changes in solution continued to take place and spread away from the cathodically protected corrosion site.

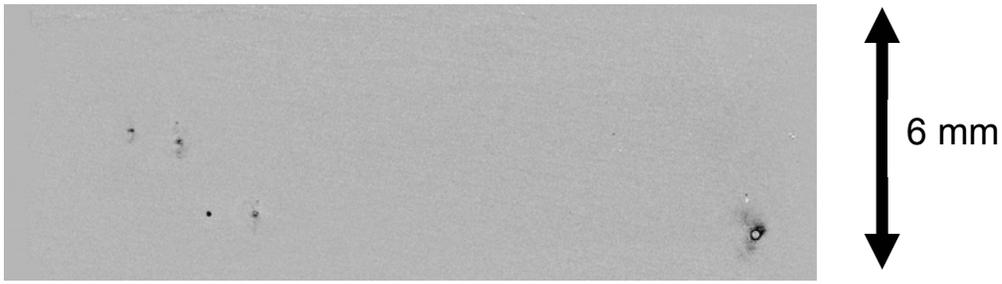
**Figure 2.** A difference image taken during the third scan showing sites of localized corrosion during the increase in anodic current.

Figure 2 shows a difference image taken during the third scan. Here the first image was taken before the anodic current had increased, the second while the anodic current was increasing. When corrosion was in progress the sites were very dark, possibly due to diffraction of light in the concentrated solution around the sites. When corrosion stopped, the sites were longer dark. At times bubbles coming from the site also appear dark, but these were intermittent occurrences. Additional processing of this image showed pH changes around the corrosion sites associated with a limited period of diffusion. Here the difference image showed the site as dark spots in contrast to that seen in Figure 1. Hence the white or dark spots offer a way to determine the chronology of the different corrosion sites even without the addition of a pH indicator.

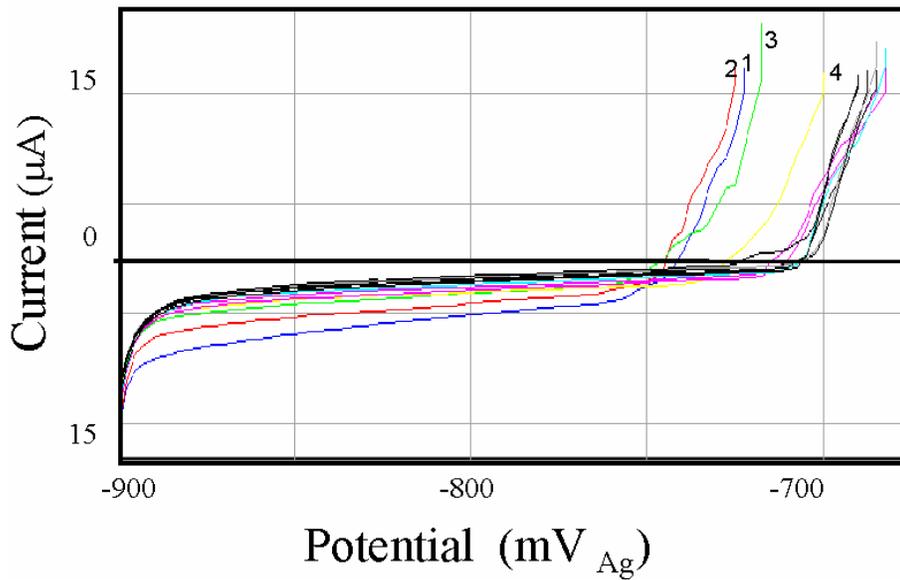
**Figure 3.** Repeated polarization scans at 1mV/sof the weld region shown in Figure 1 in 0.05 M NaCl.

Figure 3 shows a series of pitting potential measurements. The first five scans show a clear trend of increasing pitting potential indicating decreasing corrosion susceptibility. The fifth to tenth scans show very similar pitting potentials. This behavior suggests that the location of corrosion could be significantly different if the exposure conditions were different. A single continuous exposure would initiate at the more susceptible sites and corrosion could continue at these sites once initiated. However, if exposed to a periodically aggressive environment the location or number of the sites would change. The traditional approach of relying on single tests followed by post test observations would make it extremely difficult to assess the susceptibility of the different corrosion sites. In addition, in situ imaging has suggested a rather unexpected cause for the increased apparent susceptibility.

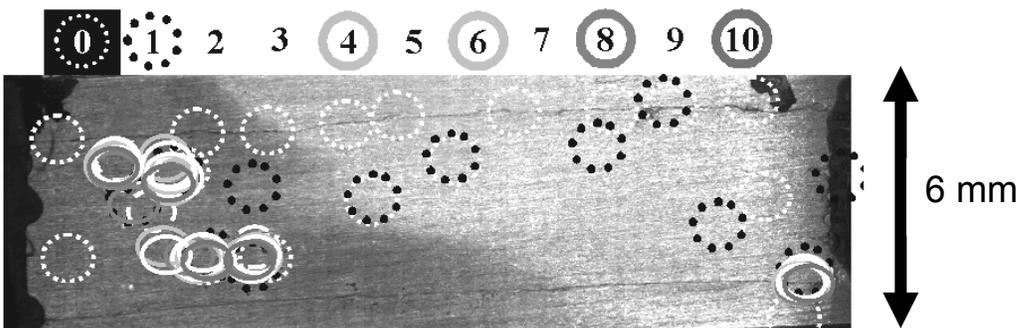
**Figure 4.** Sites of corrosion located from difference images. Time order is indicated by '0' following open and '1-10' during polarization scans. The background image was obtained prior to adding the chloride solution.

Figure 4 shows the location of all the sites detected using the difference imaging technique observed on open circuit exposure and during the ten pitting potential measurements. During the open circuit exposure there were about 11 sites of corrosion around the tape suggesting a form of crevice like corrosion, 3 sites in the weld nugget, and 4 sites in the dark area etched by the NaOH. The first scan produced 3 sites adjacent to the tape, 4 in the weld nugget, and 6 in the etched area.
